March 30, 2016
Project No. 16-1957

Subject: Landslide Hazard Study
5920 SW 48th Avenue Subdivision
Portland, Oregon

RE: Landslide Hazard Assessment – Residential Development, 5920 SW 48th Avenue Subdivision,
Portland, OR

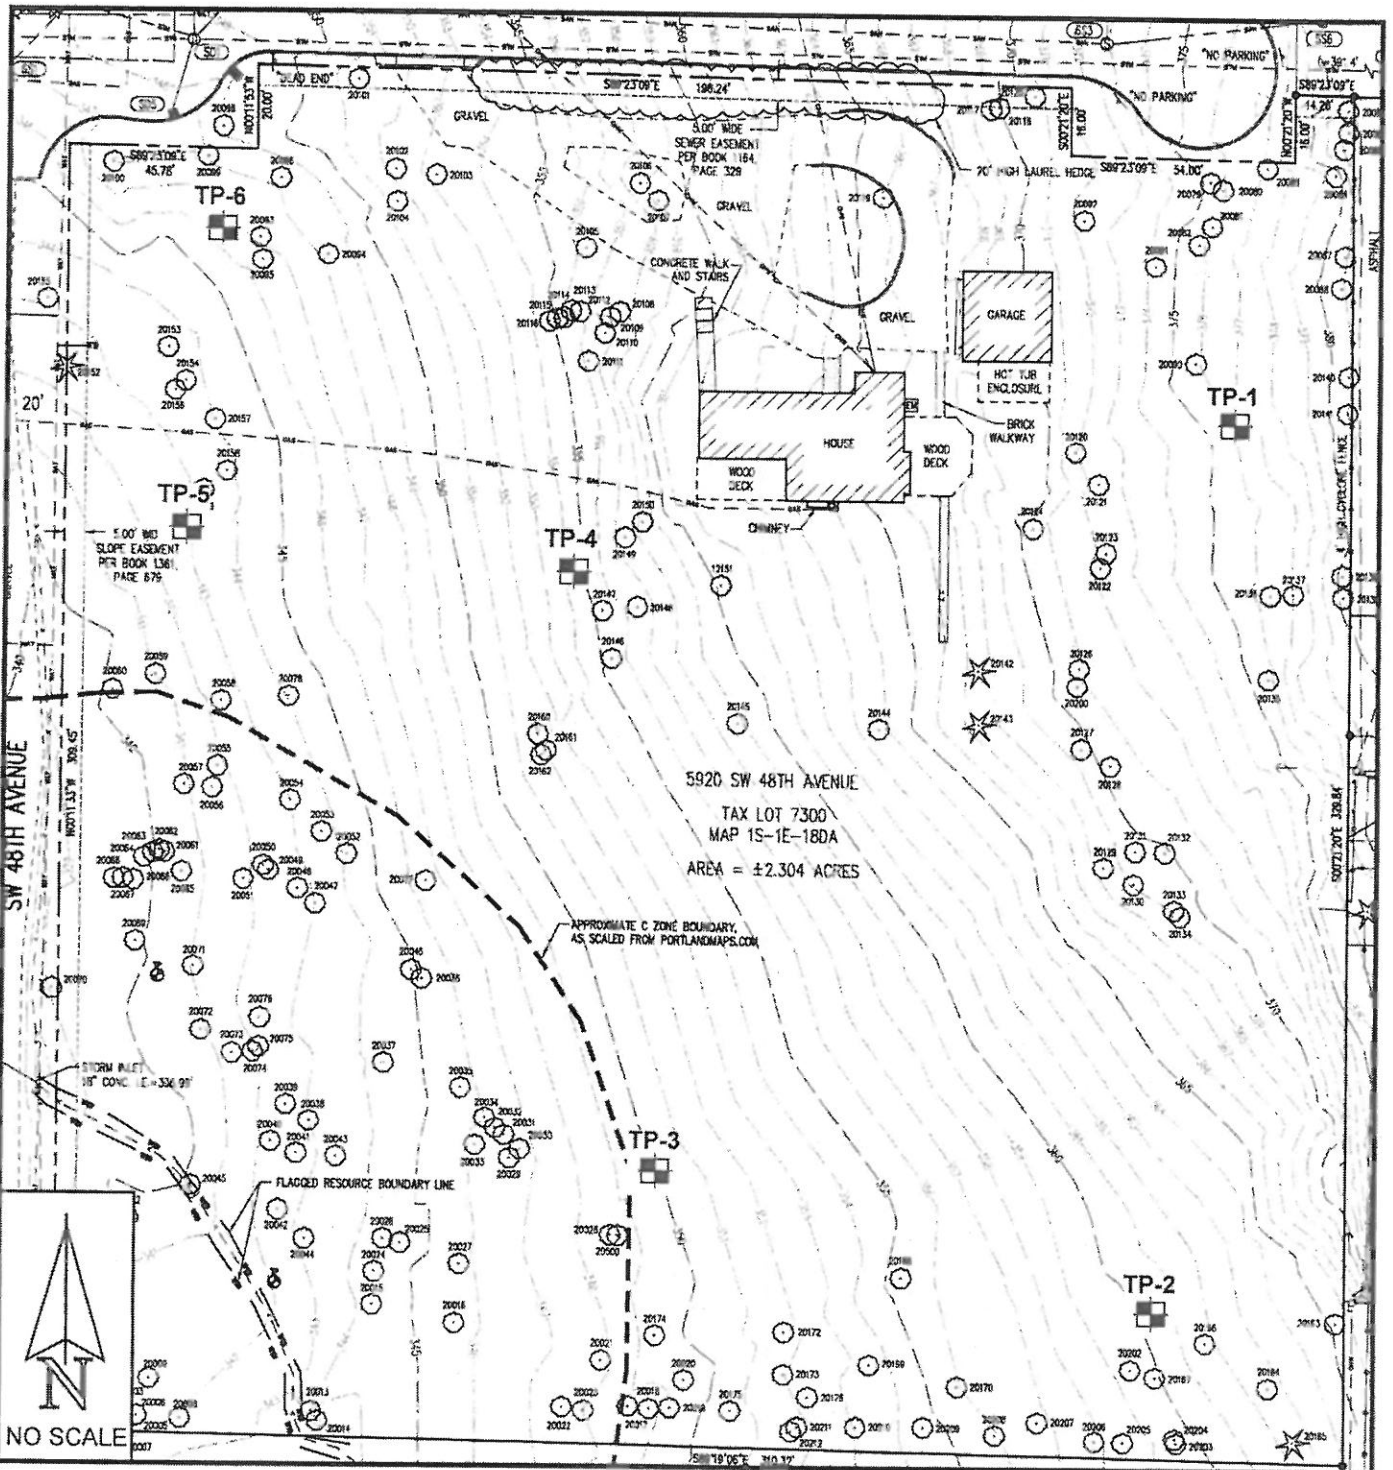
FIGURE 2

On January 26, 2016, HGSI excavated six backhoe test pits, designated TP-1 through TP-6, and performed falling head infiltration tests. The tests were conducted using the open-hole method. Infiltration testing was performed at depths of 4, 7 and 9 feet below ground surface (bgs) in test pits TP-3, TP-4 and TP-5 respectively. Measured infiltration rates were 0.1 inch/hour at the test depths in TP-3 and TP-4. In TP-5 at 9 feet bgs an infiltration rate of 2.0 inches/hour resulted.

The test pits were excavated using a small excavator, at the approximate locations shown on the attached site plan (Figure 2). It should be noted that exploration locations were determined in the field by pacing or taping distances from apparent property corners and other site features shown on the plans provided and should therefore be considered approximate. During the exploration, HGSI observed and recorded pertinent soil information such as color, stratigraphy, strength, and soil moisture. Soils were classified in general accordance with the Unified Soil Classification System (USCS). At the completion of the test pit and infiltration testing, the excavation was backfilled using the excavated soils tamped into place.

As indicated on HGSI Figure 2 (Attached) a ditch crosses the southwestern conservation area. Some standing water was observed in low areas. Tree locations are indicated on HGSI Figure 2. Much of the property is open without trees where vegetation includes shrubs and a ground cover of blackberries or English ivy. Where the ground was disturbed from the test pit excavations bare soil is present that was wet from incident rainfall.

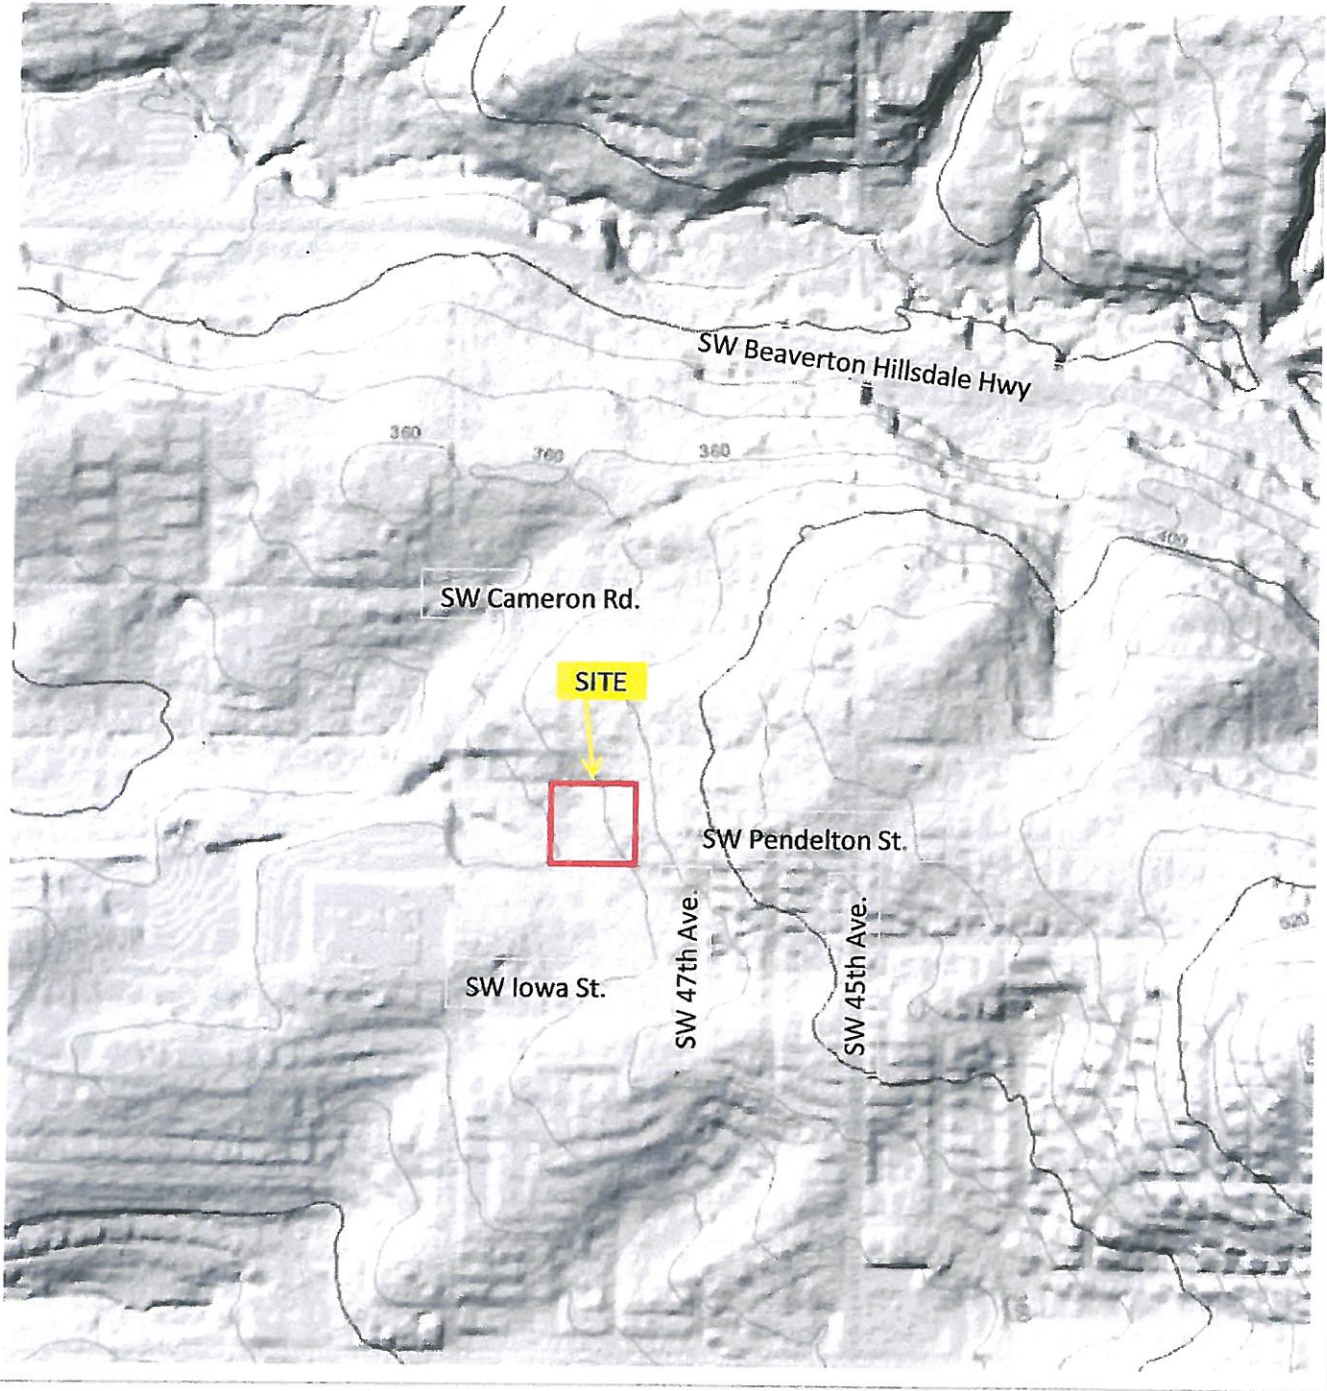
Figure 2: Lidar Hillshade Map
5920 SW 48th Ave. Subdivision, Portland, Oregon

The Oregon Department of Geology and Mineral Industries (DOGAMI) maintain a data base of landslides in an online web service: Statewide Landslide Information Database for Oregon (SLIDO). The latest version of SLIDO (release 3.2) was viewed³. Mapped landslides are not shown on the Site or immediate site vicinity. The closest mapped landslide is approximately 2,400 feet to the northwest and located along the side slope of a northwest flowing creek, a tributary to Fanno Creek. That slide is characterized as a shallow complex earth slide and earth flow. Two other similar landslides are located approximately 2,600 and 3,300 feet from the Site to the northeast and southwest, respectively.
